Review of Environmental Factors

Gosford Library Demolition

Central Coast Council

1 October 2024

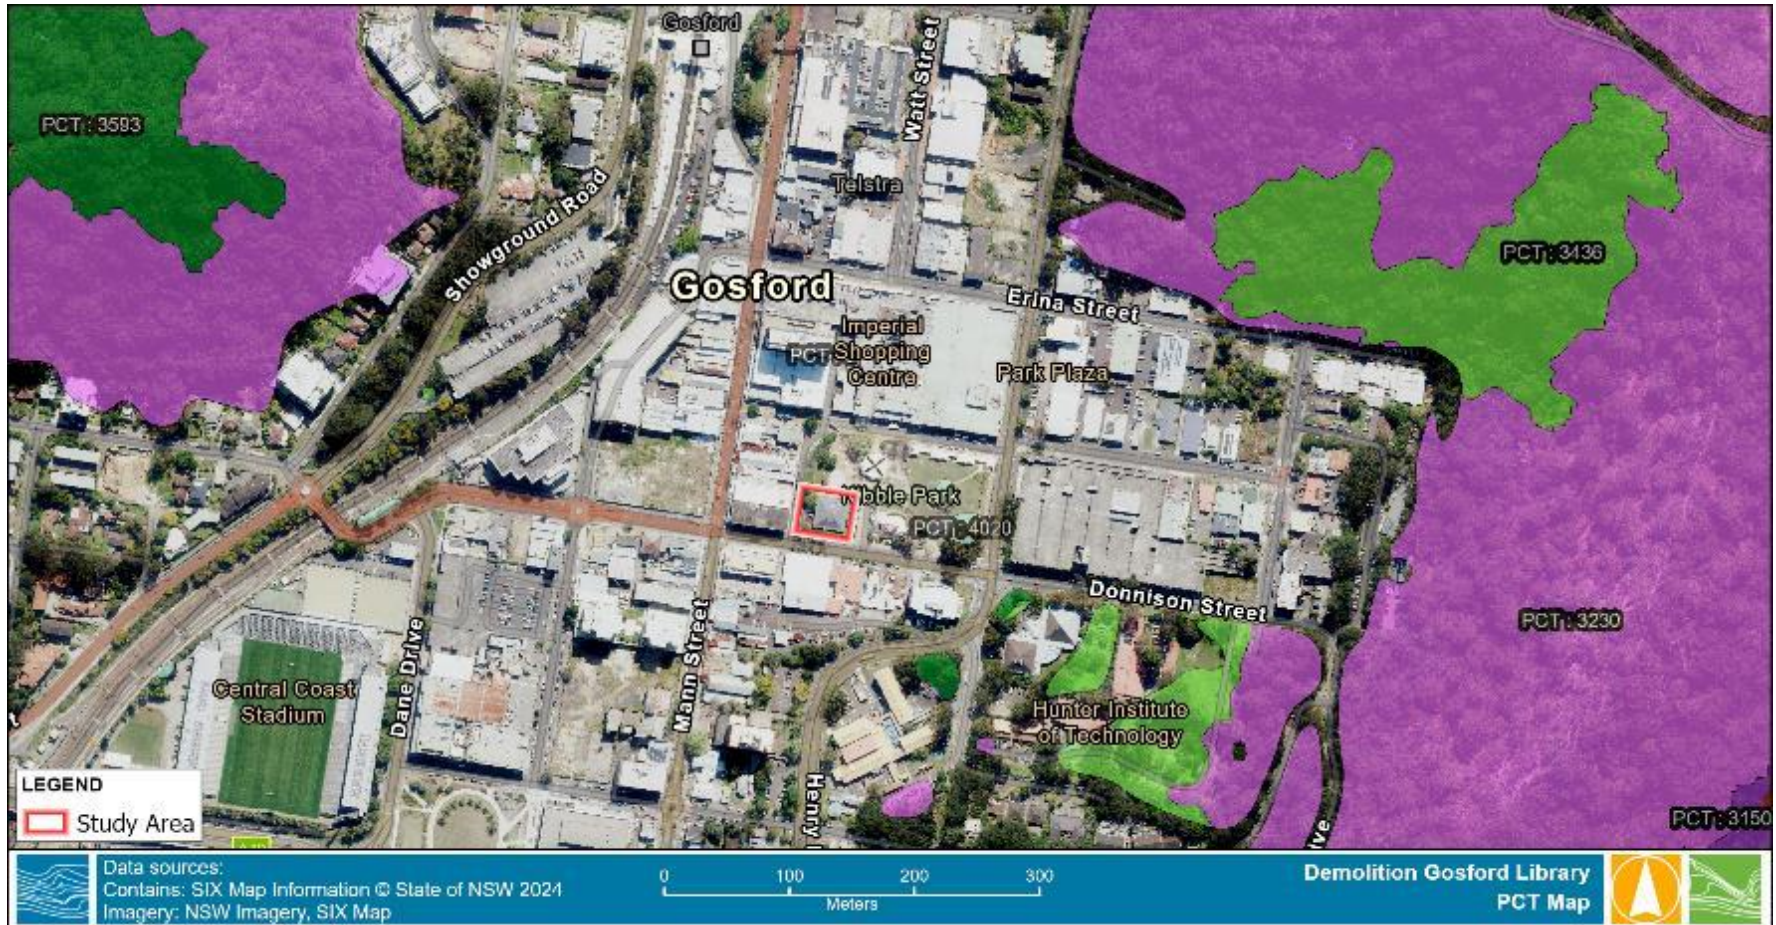
Figure 5-2 Plant Community Type (PCT) Map

A review of the vegetation mapping databases using the NSW Government The Central Resource for Sharing and Enabling Environmental Data in NSW (SEED) portal was undertaken to identify Plant Community Types (PCTs) present within the area. As indicated in Figure 5-2, no PCT's were mapped as being present within the project site. The closest mapped PCTs are PCT 3436 and PCT 3230 which are east of the site and are unlikely to be impacted by the proposed works in any way.

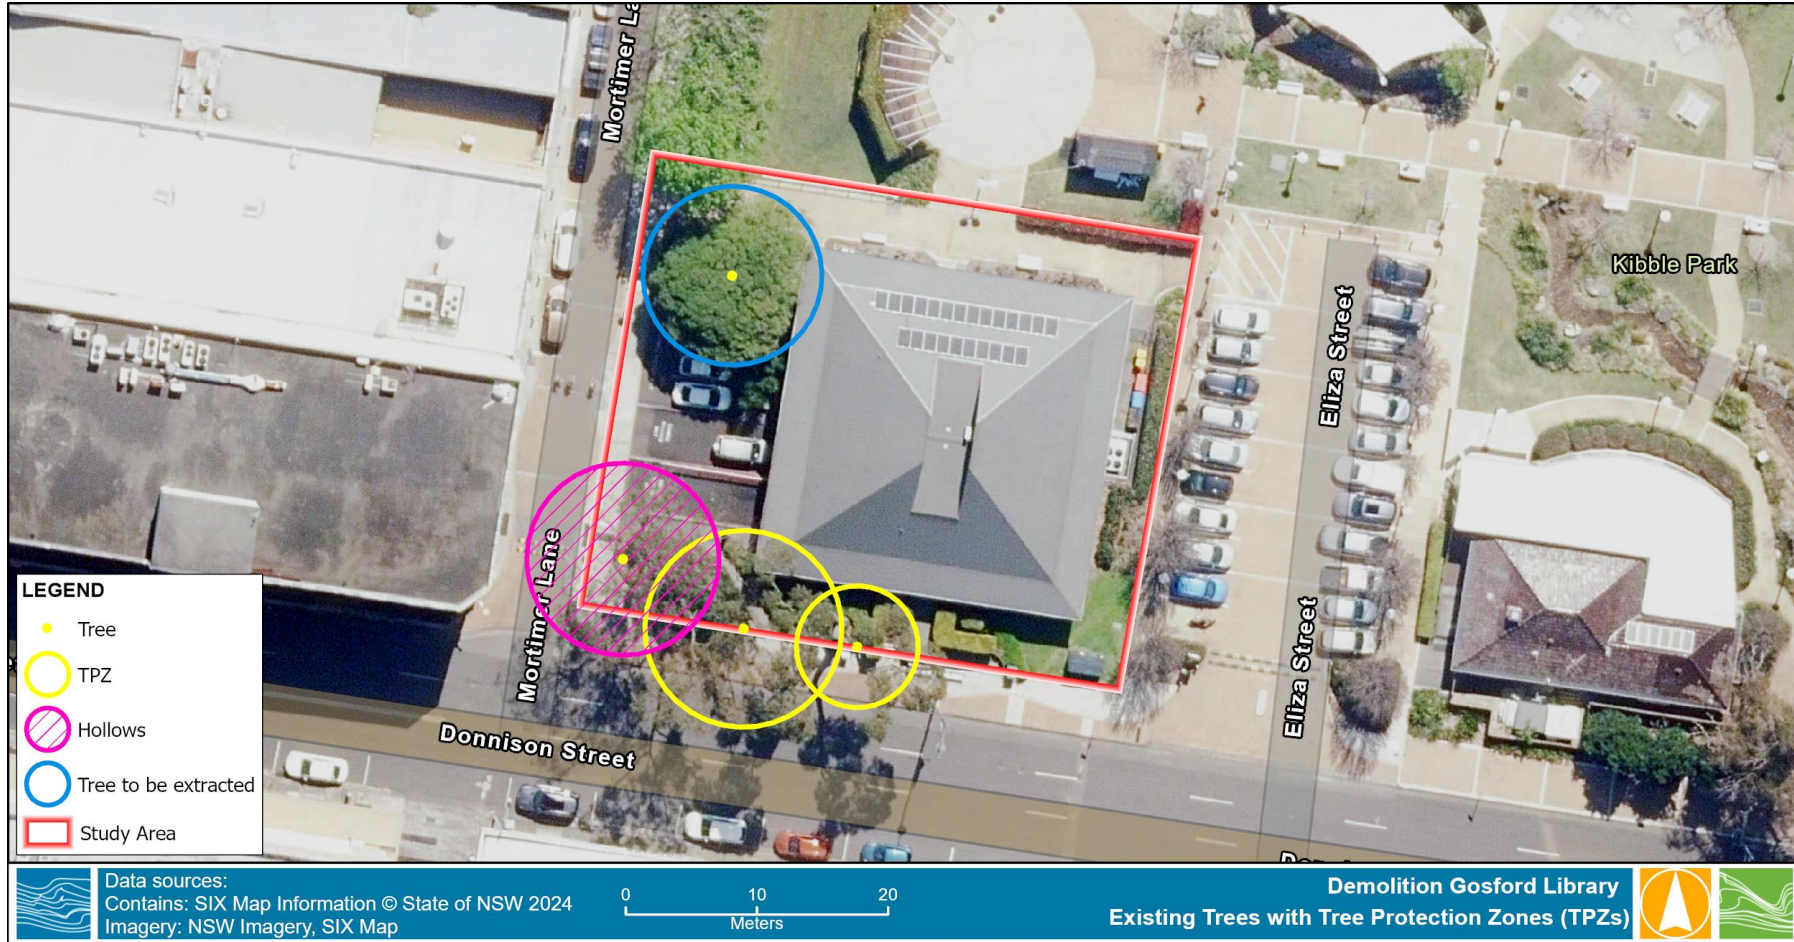
Figure 5-4 TPZ and Hollows Map

Hollows were found in the River Red Gum (Figure 5-4). So it is expected that birds, mammals and reptiles may use this tree for nesting and shelter. No operational impacts to fauna are anticipated as a result of the proposal. All hollows should be checked for fauna before the demolition proceeds.

The Formosan ash is an exotic tree in the northwest corner of the site will be removed. No hollows and nests were found in this tree (Figure 5-4). However, the ash tree may be used as habitat for fauna so the tree should be inspected for faunal habitat before it is extracted. The vegetation marked for removal should be inspected before removal to ensure no fauna will be harmed.

It is important to note that activities are scheduled to take place within the Tree Protection Zone (TPZ). The Eucalyptus trees should be protected to avoid them being damaged. As the demolition takes place in an area of the TPZ precautions should be taken (Figure 5-4) Appendix E).

Hollows were found in the River Red Gum. So it is expected that birds, mammals and reptiles may use this tree for nesting and shelter. However, this tree will be retained. No operational impacts to fauna are anticipated as a result of the proposal.

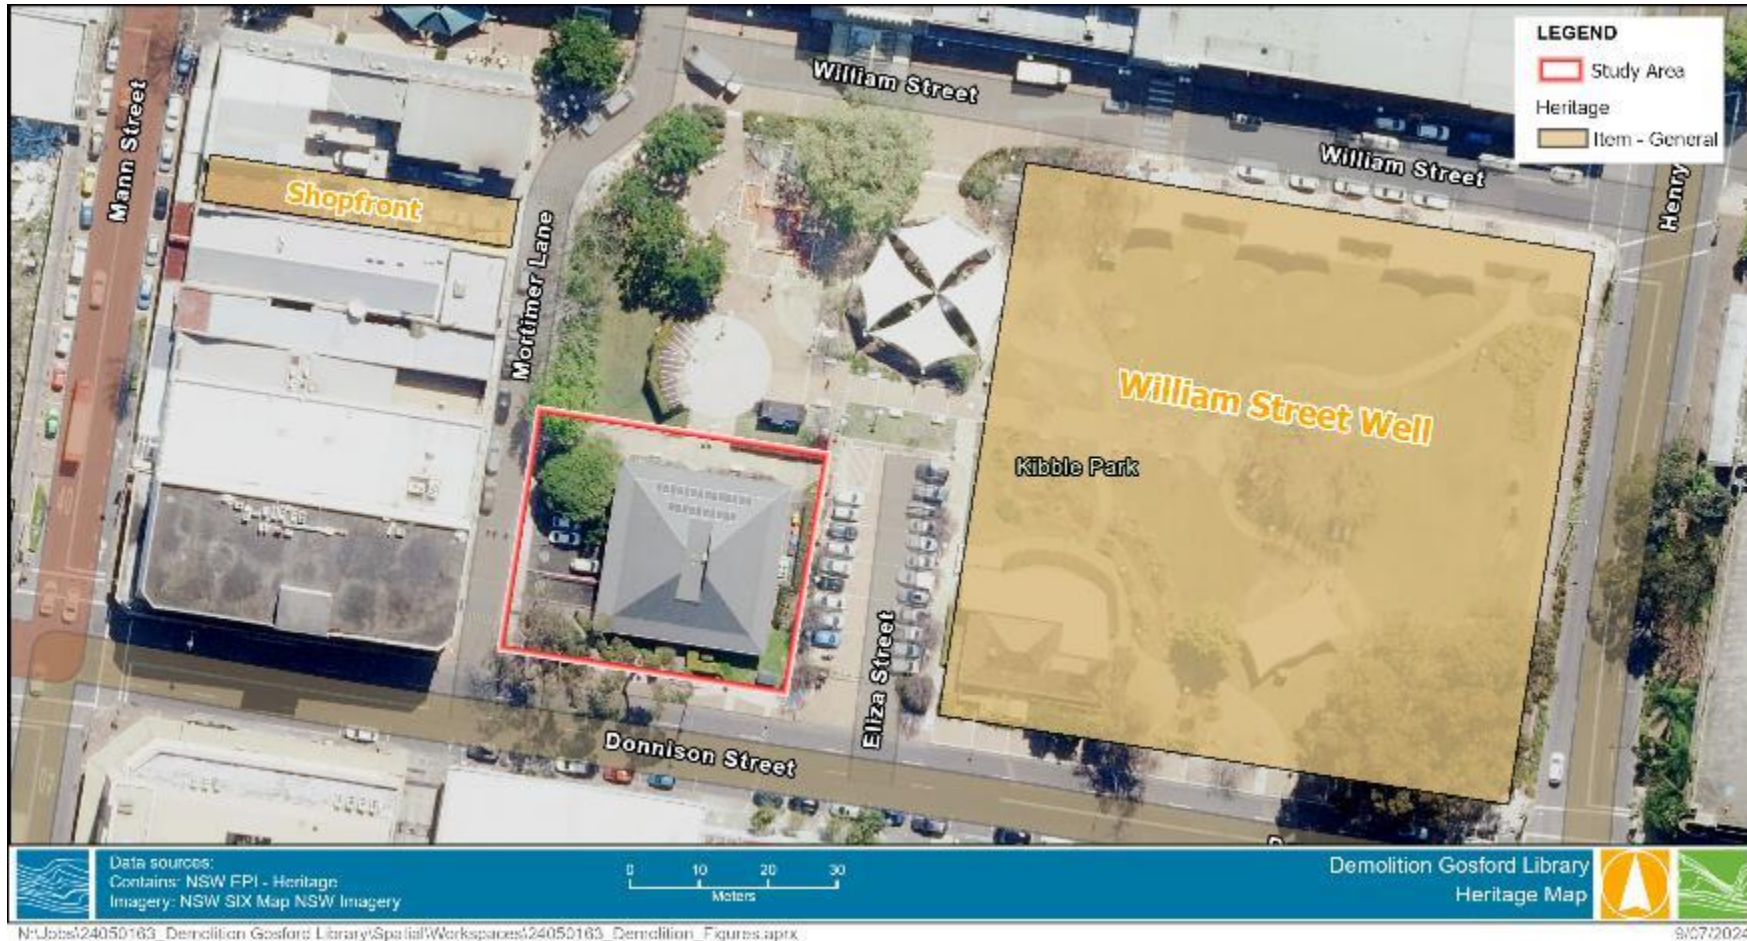
Figure 5-5 Heritage Map

Two Heritage sites were found near the study site, including a Shopfront and the William Street Well both were listed under the State Environmental Planning Policy (Gosford City Centre) 2018 (Figure 5-5). The demolition of the Gosford Library will not impact these heritage items as they are located at a considerable distance.

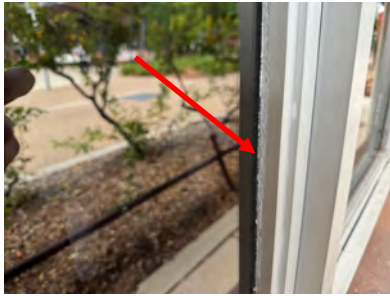
External, timber window frames, brown putty (all timber window brown putty throughout presumed the same)	Asbestos	2161-01-11	No Asbestos Detected	-	-	-	-	-	-	-	-

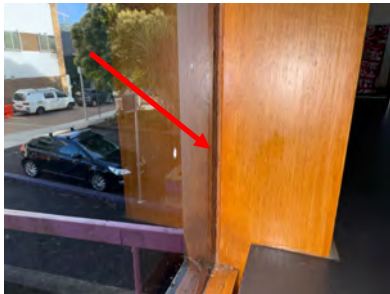
External, timber roof framing, navy / white paint system	Lead	2616-01-LP12	Non-lead paint (<0.1%)	-	-	-	-	-	-	-	-

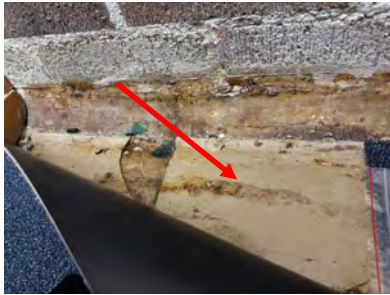
Location / Material Description	Hazard Type	Sample Ref.	Material Status	Est. Extent (m ²)	Risk Assessment				Risk Status	Action Priority	Recommendations	Photograph
					Friability	Condition	Accessibility	Labelling				
Internal, staff office area, brown glue beneath cream vinyl floor tile concealed by carpet	Asbestos	2161-01-05	No Asbestos Detected	-	-	-	-	-	-	-

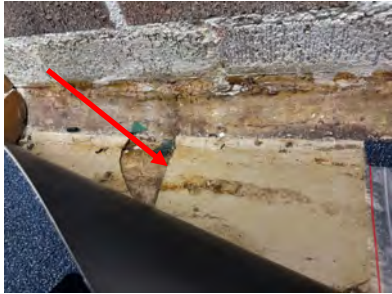
Internal, ground level, storage room, white vinyl floor tiles	Asbestos	2161-01-02	Asbestos Detected	15	1	3	1	5	L	P3	<p>Manage in accordance with Corrective Management Action (CMA) table.</p> <p>Removal by LARC prior to refurbishment / demolition works.</p> <p>Refer to Section 9 for more details</p>

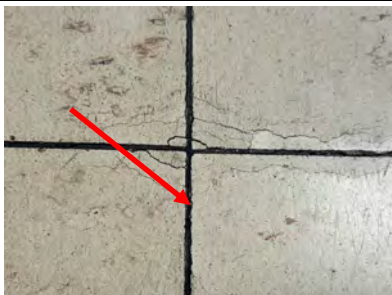
Location / Material Description	Hazard Type	Sample Ref.	Material Status	Est. Extent (m ²)	Risk Assessment				Risk Status	Action Priority	Recommendations	Photograph
					Friability	Condition	Accessibility	Labelling				
Internal, ground level, stack room, white vinyl floor tiles	Asbestos	Presumed same as 2161-01-02	Asbestos Detected	32	1	3	1	5	L	P3	<p>Manage in accordance with Corrective Management Action (CMA) table.</p> <p>Removal by LARC prior to refurbishment / demolition works.</p> <p>Refer to Section 9 for more details.</p>

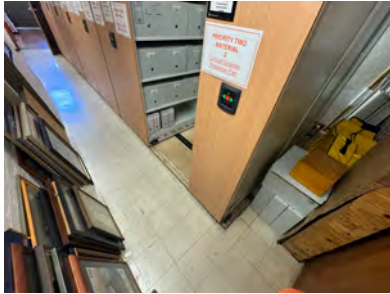
Internal, ground level, stack room, bituminous glue beneath vinyl floor tiles	Asbestos	Presumed same as 2161-01-03	No Asbestos Detected	-	-	-	-	-	-	-	-

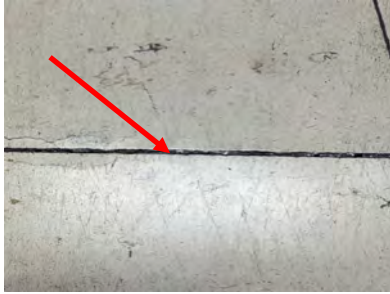
Internal, ground level, kitchen, white vinyl floor tiles	Asbestos	Presumed same as 2161-01-02	Asbestos Detected	16	1	3	1	5	L	P3	<p>Manage in accordance with Corrective Management Action (CMA) table.</p> <p>Removal by LARC prior to refurbishment / demolition works.</p> <p>Refer to Section 9 for more details.</p>

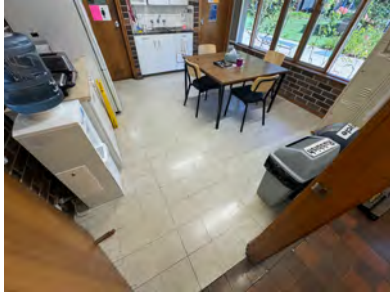
Location / Material Description	Hazard Type	Sample Ref.	Material Status	Est. Extent (m ²)	Risk Assessment				Risk Status	Action Priority	Recommendations	Photograph
					Friability	Condition	Accessibility	Labelling				
Internal, ground level, kitchen, bituminous glue beneath vinyl floor tiles	Asbestos	Presumed same as 2161-01-03	No Asbestos Detected	-	-	-	-	-	-	-

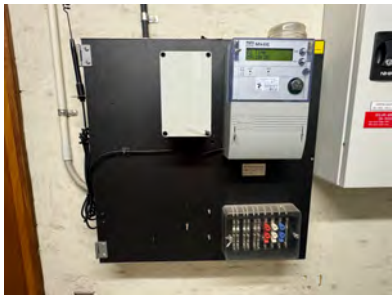
Internal, ground level, electrical room, rectangle backing boards (x2)	Asbestos	N/A Electrical Hazard	Presumed Asbestos-Containing	1	1	3	1	5	L	P3	<p>Confirm material status by sampling and NATA accredited analysis following electrical isolation.</p> <p>Manage in accordance with Corrective Management Action (CMA) table.</p> <p>Removal by LARC prior to refurbishment / demolition works.</p> <p>Refer to Section 9 for more details.</p>

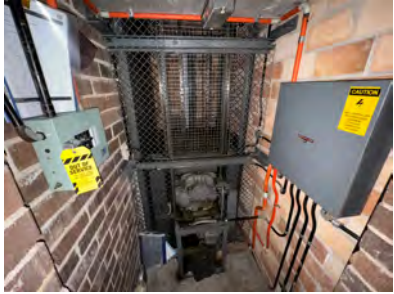
Internal, ground level, stack room, brick walls, white paint system	Lead	2616-01-LP06	Non-lead paint (<0.1%)	-	-	-	-	-	-	-	-

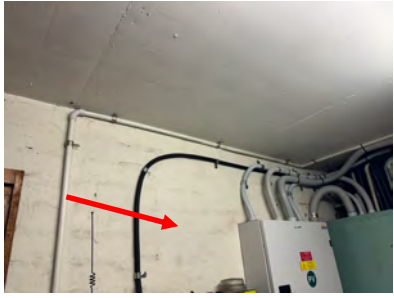
Internal, ground level, substation room, concrete ceiling, white paint system	Lead	2616-01-LP08	Non-lead paint (<0.1%)	-	-	-	-	-	-	-	-

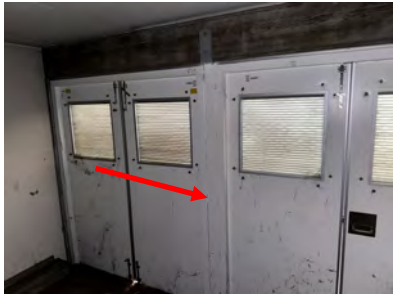
Location / Material Description	Hazard Type	Sample Ref.	Material Status	Est. Extent (m ²)	Risk Assessment				Risk Status	Action Priority	Recommendations	Photograph
					Friability	Condition	Accessibility	Labelling				
Internal, plant room, brick walls, white paint system	Lead	2616-01-LP10	Non-lead paint (<0.1%)	-	-	-	-	-	-	-	-

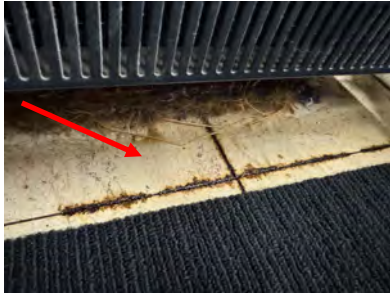
Internal, first level, IT / server room, bituminous glue beneath white vinyl floor tiles concealed by carpet	Asbestos	2161-01-10	No Asbestos Detected	-	-	-	-	-	-	-	-

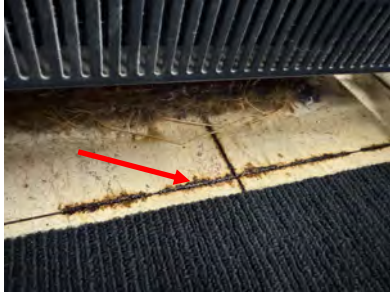
Internal, first level, reading room, white vinyl floor tiles concealed by carpet	Asbestos	2161-01-07	Asbestos Detected	1	1	3	1	5	L	P3	<p>Full extent yet to be determined.</p> <p>Manage in accordance with Corrective Management Action (CMA) table.</p> <p>Removal by LARC prior to refurbishment / demolition works.</p> <p>Refer to Section 9 for more details.</p>

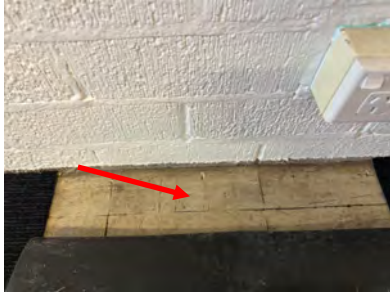
Location / Material Description	Hazard Type	Sample Ref.	Material Status	Est. Extent (m ²)	Risk Assessment				Risk Status	Action Priority	Recommendations	Photograph
					Friability	Condition	Accessibility	Labelling				
Internal, first level, reading room, bituminous glue beneath white vinyl floor tiles concealed by carpet	Asbestos	2161-01-08	No Asbestos Detected	-	-	-	-	-	-	-	-

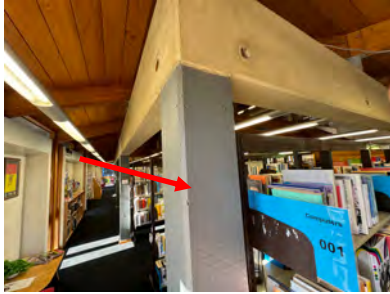
Internal, first level, vertical concrete columns, grey / purple paint system	Lead	2616-01-LP01	Non-lead paint (<0.1%)	-	-	-	-	-	-	-	-

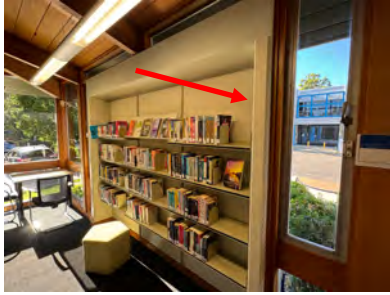
Internal, first level, book shelve enclosures, white paint system	Lead	2616-01-LP02	Non-lead paint (<0.1%)	-	-	-	-	-	-	-	-

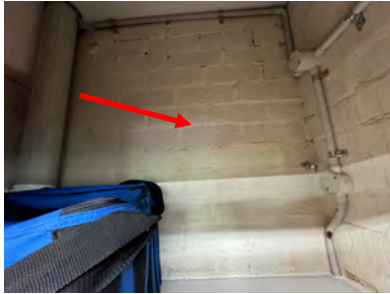
Location / Material Description	Hazard Type	Sample Ref.	Material Status	Est. Extent (m ²)	Risk Assessment				Risk Status	Action Priority	Recommendations	Photograph
					Friability	Condition	Accessibility	Labelling				
Internal, first level, storage cupboard, brick walls, white / cream paint system	Lead	2616-01-LP03	Non-lead paint (<0.1%)	-	-	-	-	-	-	-	-

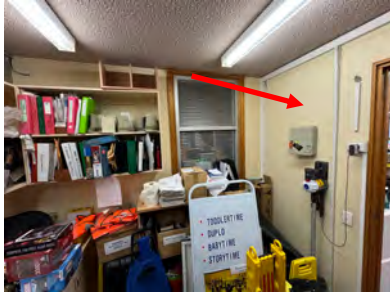
Internal, first level, IT / server room, concrete rendered walls, yellow paint system	Lead	2616-01-LP04	Non-lead paint (<0.1%)	-	-	-	-	-	-	-	-

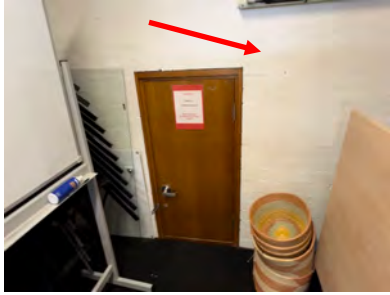
Internal, first level, reading room, brick walls, white / cream / aqua paint system	Lead	2616-01-LP05	Non-lead paint (<0.1%)	-	-	-	-	-	-	-	-

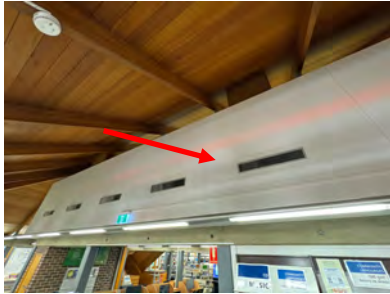
Location / Material Description	Hazard Type	Sample Ref.	Material Status	Est. Extent (m ²)	Risk Assessment				Risk Status	Action Priority	Recommendations	Photograph
					Friability	Condition	Accessibility	Labelling				
Internal, first level, AC void space	-	N/A Inaccessible	-	-	-	-	-	-	-	-	<p>The first level AC void space should be assessed for the presence of hazardous materials by a Competent Person such as an Assessment Corp LAA, during demolition / refurbishment works when adequate access is available.</p> <p>Refer to Section 9 for more details.</p>

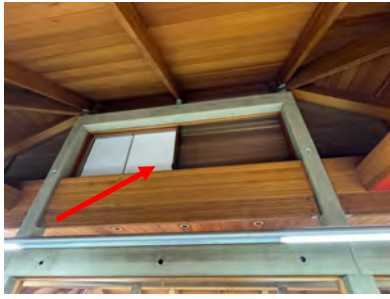
Location / Material Description	Hazard Type	Sample Ref.	Material Status	Est. Extent (m ²)	Risk Assessment				Risk Status	Action Priority	Recommendations	Photograph
					Friability	Condition	Accessibility	Labelling				
Internal, second level, concealed room	-	N/A Inaccessible	-	-	-	-	-	-	-	<p>The second level concealed room should be assessed for the presence of hazardous materials by a Competent Person such as an Assessment Corp LAA, during demolition / refurbishment works when adequate access is available.</p> <p>Refer to Section 9 for more details.</p>

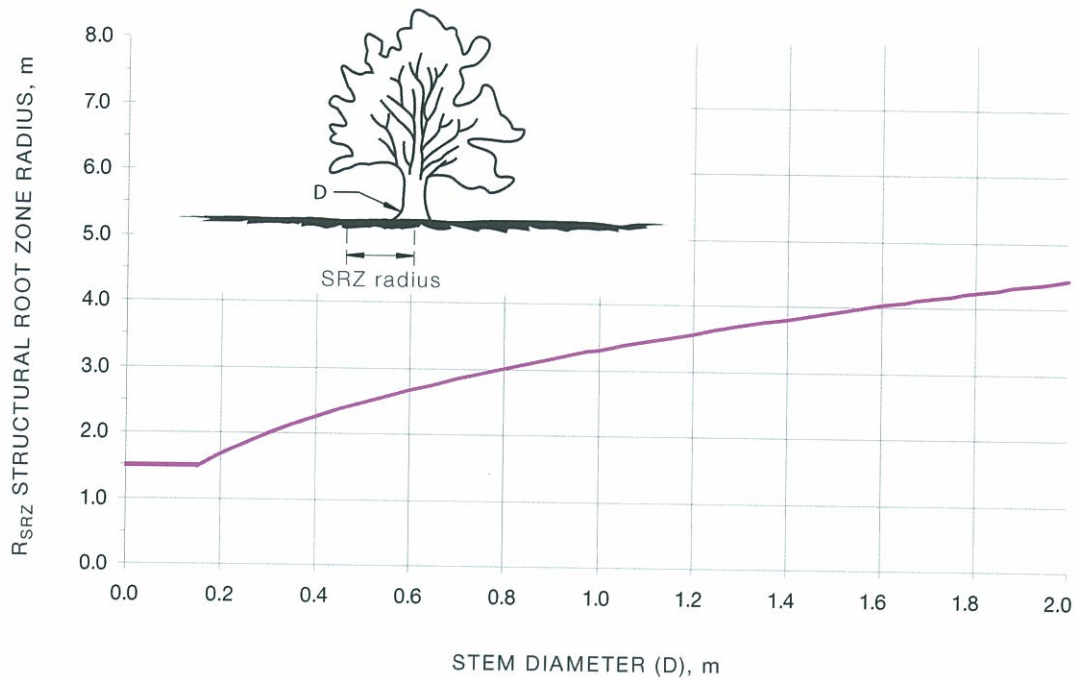
The curve can be expressed by the following formula:
 $R_{SRZ} = (D \times 50)^{0.42} \times 0.64$
