Blue Lagoon staircase installation: CPA/5690

REVIEW OF ENVIRONMETAL FACTORS

Job No: 240821

Review of Environmental Factors, Blue Lagoon Staircase Installation.

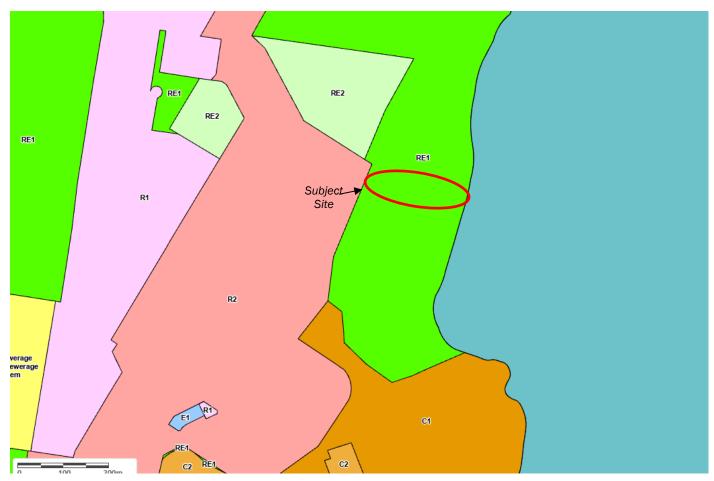
Figure 1-3. Central Coast Council Local Government Area Online Mapping" Zoning Maps accessed 14/11/2024 https://maps.centralcoast.nsw.gov.au/public/

The Subject Site is zoned RE1 Public Recreation under Central Coast Local Environmental Plan (LEP) 2022 (Figure 1-3). Zone RE1 Public Recreation

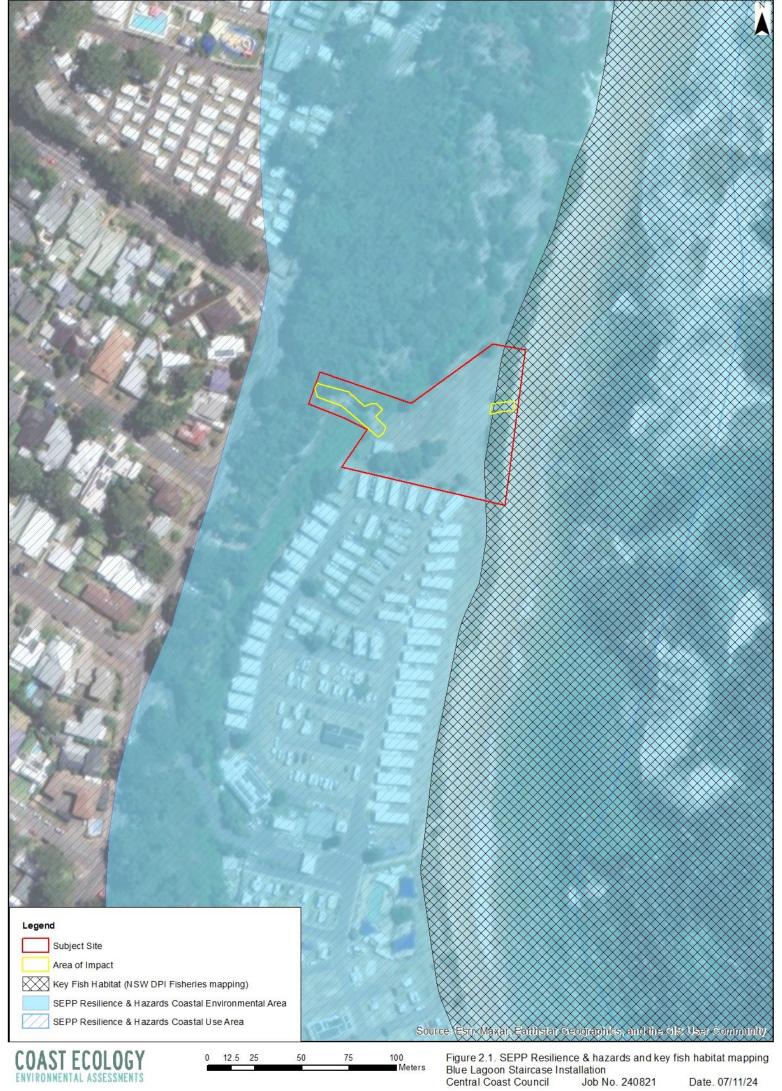
Detailed interactive maps accompany the SEPP and were reviewed for relevance of this SEPP to the Subject Site (Figure 2-1).

The Subject Site is mapped as the following:

- · Coastal Environmental Area
- Coastal Use Area

A portion of the *Subject Site* where the lower steps are proposed for replacement, is mapped by NSW Department of Primary Industries (DPI) Fisheries as KFH (Figure 2-1) however the *Subject Site* and *Area of Impact* consists of terrestrial habitat only and contains no aquatic features. As such, the requirement for a part 7 permit application for dredging and reclamation in accordance with the FM Act is not considered appropriate in this instance.

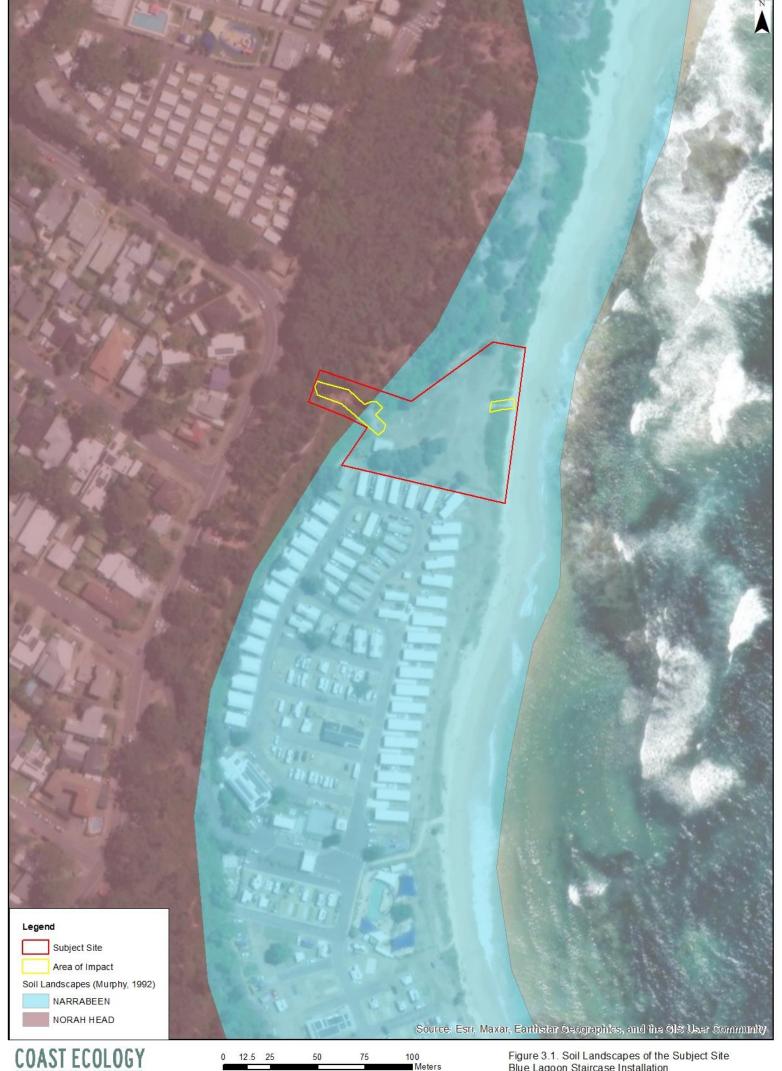
Figure 3.1. Soil Landscapes of the Subject Site Blue Lagoon Staircase Installation Central Coast Council Job No. 240821 Date. 22/12/24

Geology consists of aeolian quartz dunes and sandsheets of Pleistocene age perched on Triassic and Permian bedrock and is mapped on the back dune at the top of the *Subject Site* near Bateau Bay Rd. This soil landscape is mostly stabilized by urban development. Areas of disturbed bushland suffer from high wind erosion. The surface condition is generally loose but may be friable when abundant organic content is present (Murphy, 1992).

Geology consists of quaternary sands consisting of marine quartz sand with shell fragments, interdune (swale) silt and fine sand and is mapped on the foredune part of the *Subject Site*. Beaches are dynamic landscapes with common processes of severe wind and wave erosion. Wind erosion can be extreme on foredunes especially where stabilizing vegetation cover is absent or disturbed. Wind erosion on foredunes is characterized by the presence of blowouts. Extreme wave erosion occurs during high seas. In many cases the seaward slope of the foredune is significantly eroded resulting in erosion scarps. During storms, large volumes of sand can be removed from the beach and deposited in the nearshore zone (Murphy, 1992).

Council should seek advice from geotechnical engineers and coastal engineers during the design phase to ensure that the proposed design is suitable for the existing soils and wave/tidal environment.

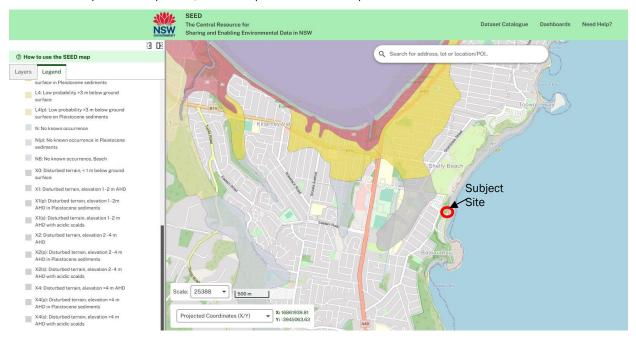
Figure 3-2. Acid sulphate soil mapping (Seed portal accessed 10/12/24)

The *Subject Site* is not mapped as potential acid sulphate soils (PASS) on the SEED portal (Figure 3-2), however on Councils Geocortex mapping, it is defined as Class 5 acid sulphate soils (Figure 3-3). Class 5 acid sulphate soils require the preparation of an acid sulphate soil Plan of Management (PoM) only if works are within 500m of class 1, 2, 3 or 4 land that is below 5 m Australian Height Datum (AHD) and by which the water table is likely to be lowered below 1 m AHD on adjacent lands.

Thus, if any excavation is likely to impact adjoining watertables, soil testing for contaminants and acid sulphate soil prior to the commencement of works is required. Material classification is to identify the potential for acid sulphate soil. If PASS or acid sulphate soil is present, an acid sulphate soil PoM is required.
